# www.Cabrio-Heckscheibe.de

# Instructions

Repair Kit for Convertible Top Hood

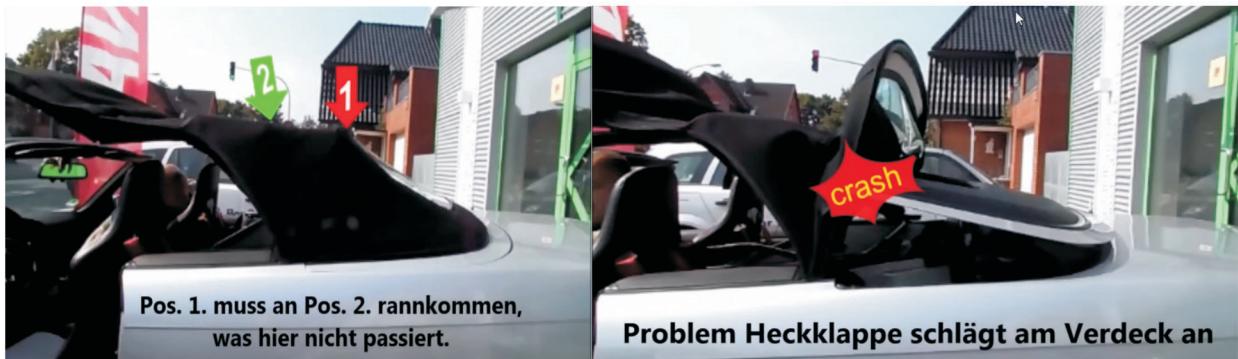
The main problem is that pos.1 doesn't move far enough towards pos.2. Our repair-kit solves this problem.

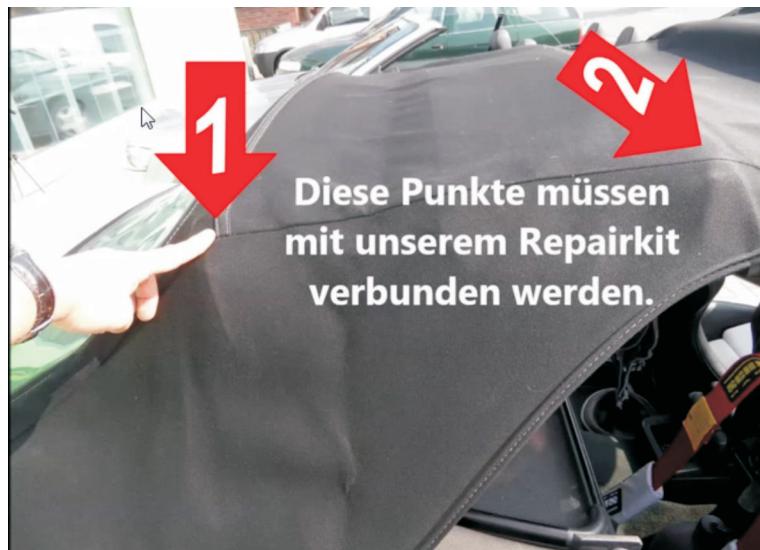
Pos.1 and 2 have to be connected through our repair-kit

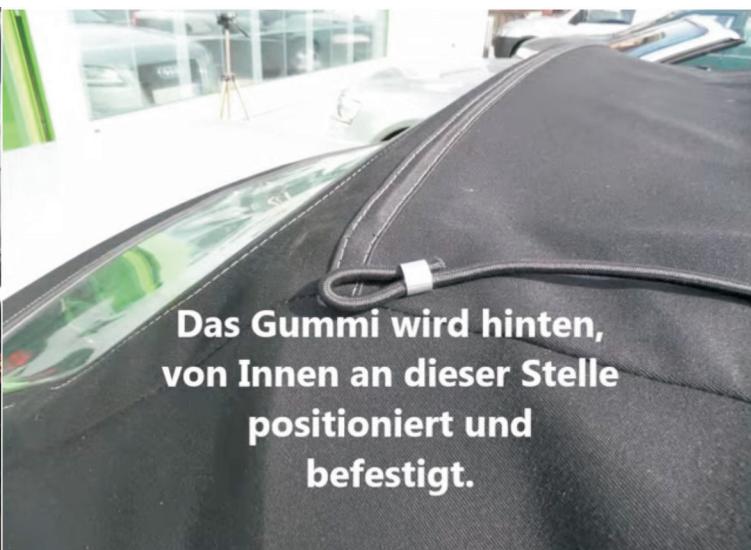
The expander has to be placed on the inside like shown on the photo

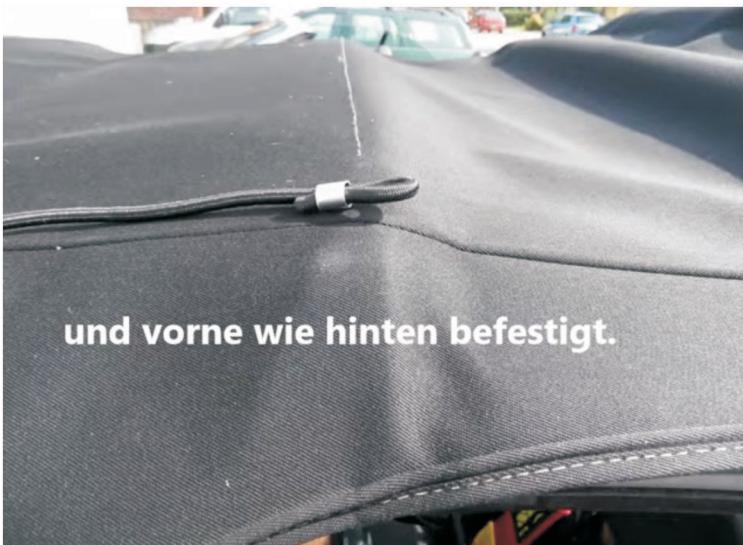
The same at this position

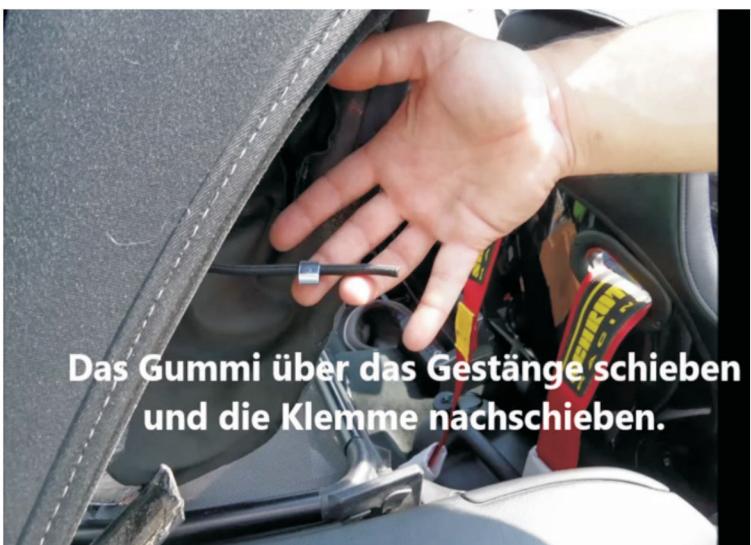
Thread the expander over the struts and push on the crimp

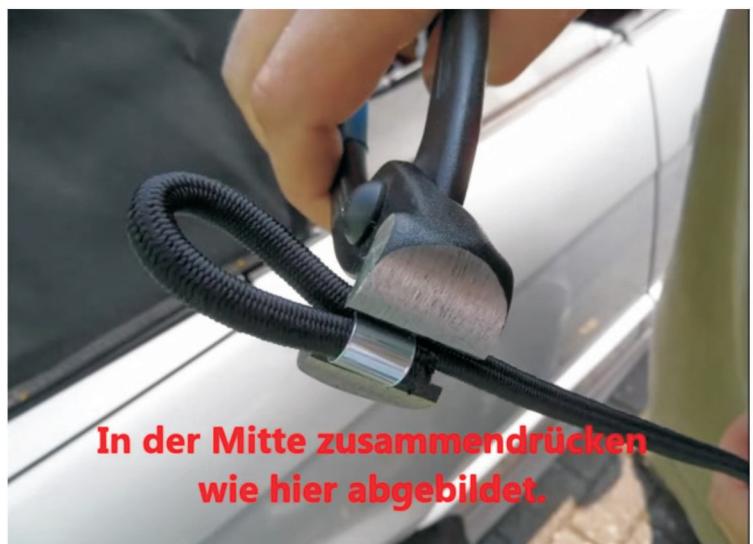
Now squeeze the crimp in the middle like shown
